Report 1443

## THE EFFECTS OF ATOMIC WEAPONS ON

ENGINEER HEAVY EQUIPMENT (U)

25 April 1956

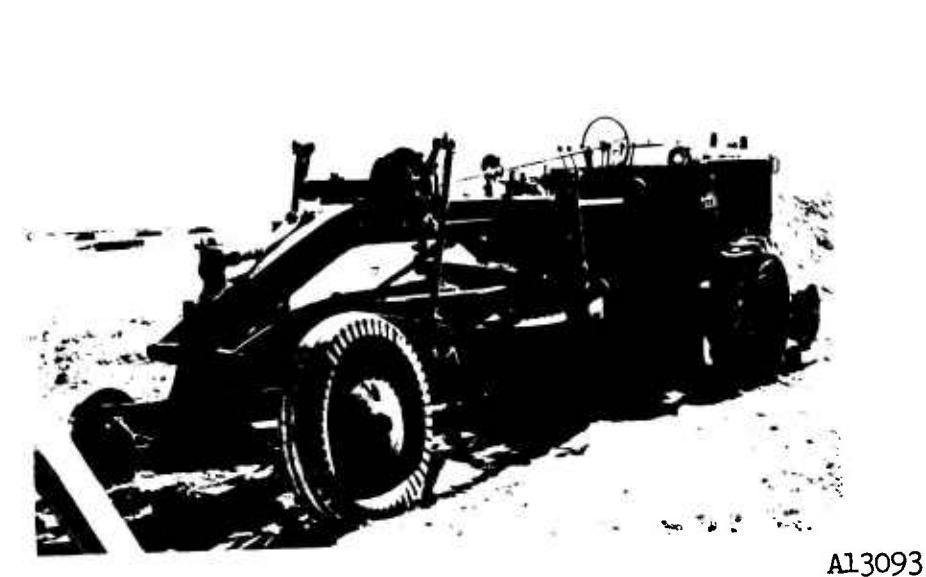
Fig. 10. Grader, 1600 ft; before test.

grader received moderate damage; the repair effort (120 hr) required was much greater than that for the comparable tractor (16 hr). The protected grader received essentially superficial damage; the wrecked cab would not have prevented the operation of the grader. Figs. 10 and 11 indicate the layout for the graders and the condition of the test items used. In Fig. 11, the wheels show how the reflected shock wave moved the grader toward GZ and forward

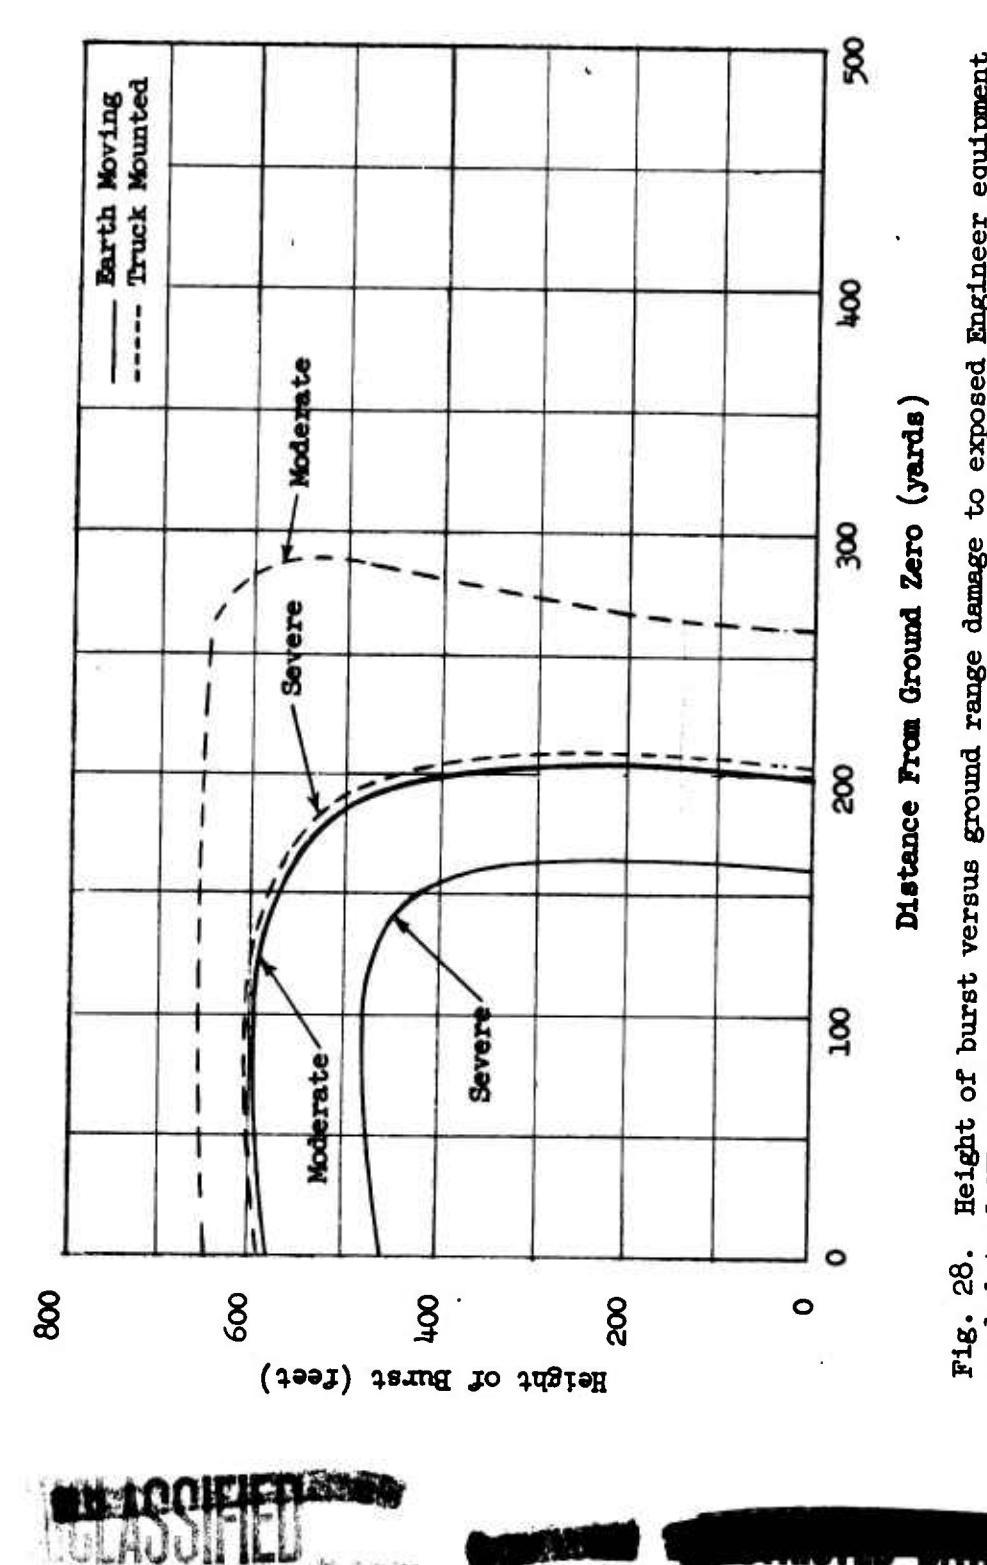
\$ 136 Fig. 28. Height of burst versus ground range damage to exposed Engineer equipment scaled to 1 KT.

Damage Criteria. The selected ranges provided an ade-9. quately narrow bracket of the range of severe damage. The relatively intense blast effects degrade rapidly because the energy of the blast wave is being attenuated on a volume basis and decreases as the cube root of the range. The 500- and 600-ft range differentials were more than enough to record the change in damage levels. The test showed clearly that all of the exposed items are drag-type targets; they are less responsive to the shock wave itself than to the high winds following the shock. However, it was also clearly evident that the dug-in items were damaged by peak pressure only. Since exposed and dug-in items are damaged by different phenomena associated with the blast wave, it seems profitable to indicate damage criteria in terms of these separate phenomena. Damage criteria in TM-23-200 indicates that damage to drag-type equipment scales as  $W^{0.4}$ , and peak pressure scales as  $W^{1/3}$ . Using these scaling methods curves are presented in Figs. 27 and 28 for height of burst versus ground range damage to engineer heavy equipment scaled to 1 KT. , In Fig. 27 for dug-in equipment, ground range has been scaled as  $W^{1/3}$ ; and in Fig. 28 for exposed equipment, ground range has been scaled as  $W^{0.4}$ . Height of burst scales as  $W^{1/3}$  in either case. The damage criteria in Figs. 27 and 28 have not been presented in terms of percent probability of damage. However, if it is desired to compare the curves with those given in TM 23-200, it is felt that they should be comparable to the 50 percent probability curves.
